Lessons from a Dam Failure¹

ABSTRACT. The IVEX Dam (Chagrin River, northeastern Ohio) failed catastrophically on 13 August 1994, releasing 38,000 m³ (about 10 million gallons) of impounded water and sediment. This event was triggered by a 70-year rainfall event (13.54 cm of rainfall within 24-hours), resulting in flows 1.9 m above the top of the spillway and impinging on the top of the dam. The failure was the result of seepage piping at the toe of the dam, near the masonry spillway-earthen dam contact. Eyewitnesses reported that collapse of the seepage pipe created a breach in the dam that rapidly downcut. Paleohydrologic modeling suggests peak discharge through the breach was about 466 m³sec⁻¹, substantially dewatering the reservoir in approximately 2-3 minutes.

OHIO J SCI 100 (5):121-131, 2000

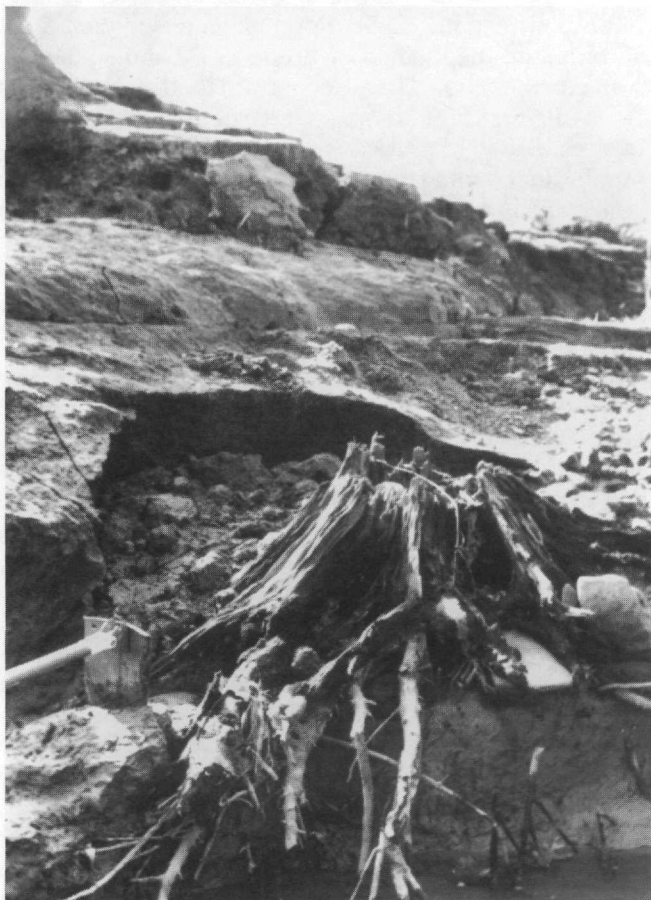
watering and subsidence of the muddy reservoir fill (Fig. 8), and slumping of the poorly consolidated reservoir sediments into the new channel of the Chagrin River (Fig. 9). Incision exposed bedrock cutbanks of the pre-reservoir channel (Fig. 10), white cedar stumps from the pre-1842 floodplain (Fig. 11), the upstream delta infilling the reservoir (Fig. 12), and examples of rhythmically-bedded, fining-upward sequences representing sequential floods over the interval 1842-1994 (Fig. 13). Core data could be used to identify specific flood horizons (Fig. 14), and calculate changes in sediment accumulation rates that occurred in the reservoir. These sedimentation rates, and corresponding changes in land-use and sediment conveyance within the drainage basin, are discussed in detail in Evans and others (2000a).

FIGURE 11. White Cedar stump from the pre-1842 floodplain forest, flooded and killed by the reservoir, and now exhumed by the dam failure. Shovel for scale is 45 cm.

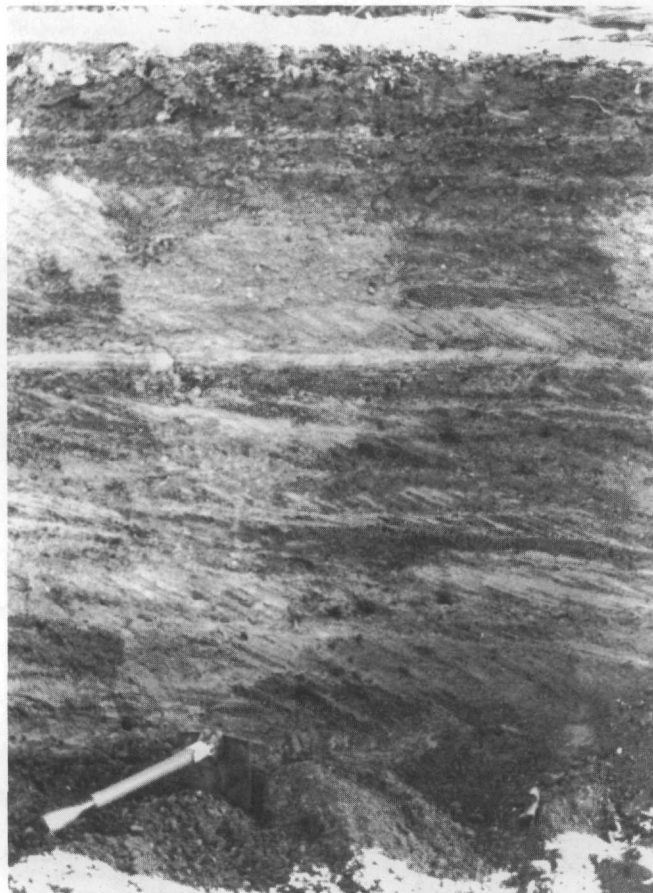
FIGURE 12. New outcrop showing the delta at the upstream end of the reservoir. This deltaic distributary mouth bar consists of sand- and gravel-foresets with climbing ripple lamination. Shovel is 45 cm long.

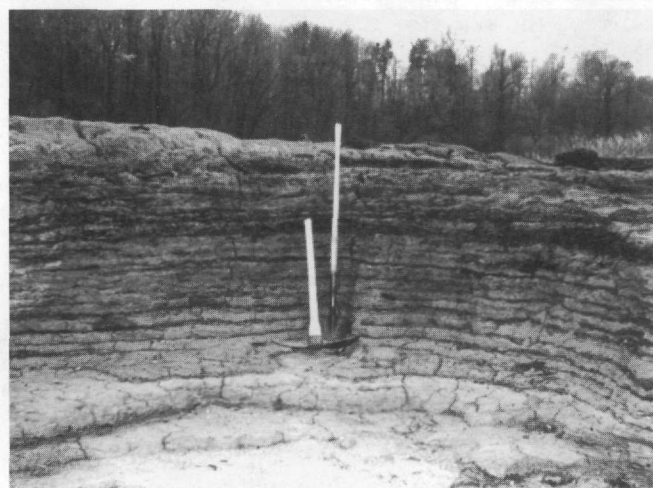
FIGURE 13. Trench exposure of the reservoir sediments showing flood rhythmites (repetitive, fining-upward sequences of sand, silt, and clay with capping organic-rich laminae). Shovel is 1.5 m tall.
